**SHORELINE
SURVEY
REPORT
&
ACTION
PLAN**

**Lake Lillinonah and Lake Zoar Stream Team
Summer 2002**

Housatonic Valley Association

LAKE LILLINONAH AND LAKE ZOAR STREAM TEAM REPORT

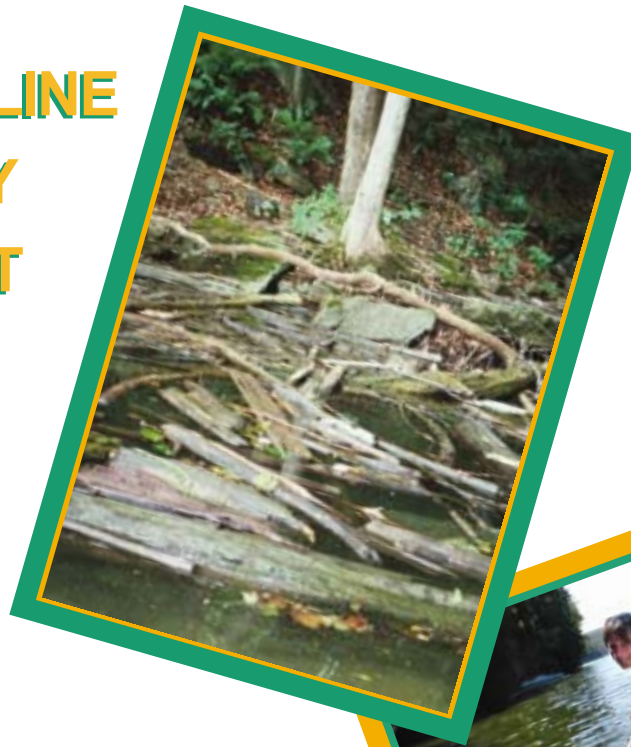
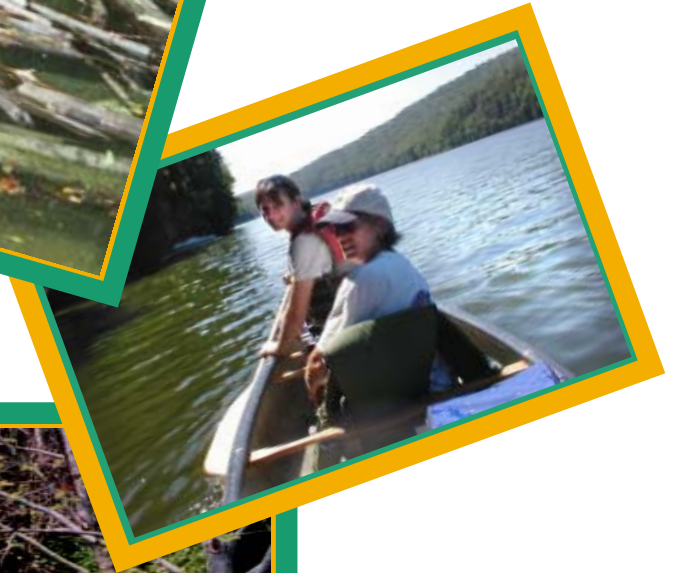
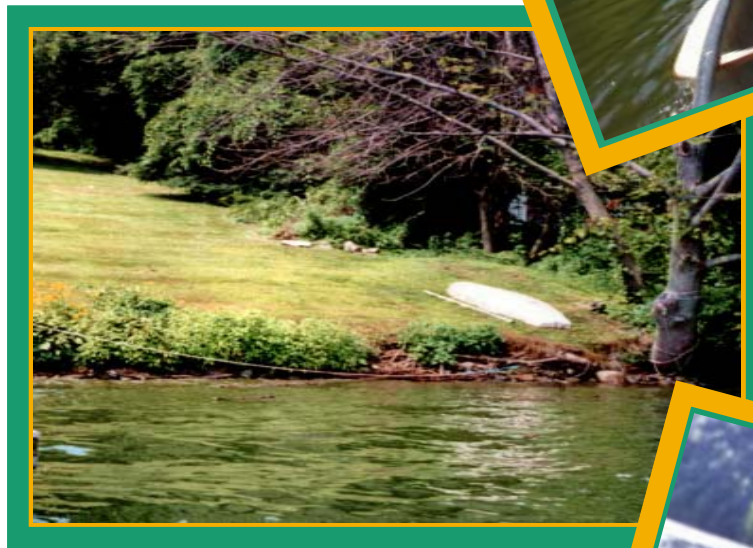
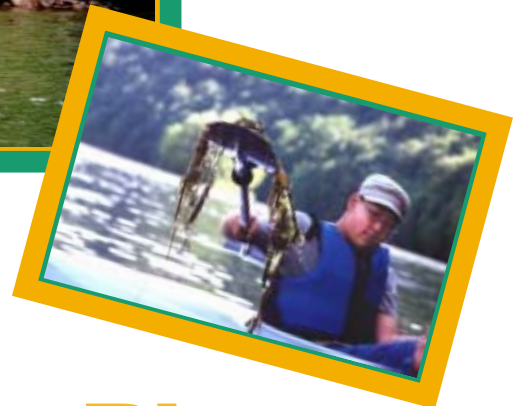
Cover photos: From top: Driftwood problem, section 5W, photo by Connie and Michael Kersten. Joanne and Shauna Barry, section 10E, photo by Erin Bertrand. Clear cutting and runoff problems, section 5W, photo by Connie and Michael Kersten. Sean Garrett with aquatic vegetation, section 2W, photo by Bill and Christine Garrett.

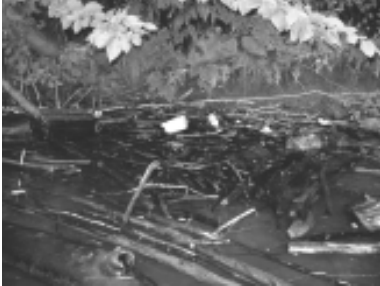
<p style="text-align: center;">Debris near the shore</p>	<ul style="list-style-type: none"> ● Clean up of trash and debris. ● Floating debris could be hazardous. Contact FERC and Northeast Generation Services regarding actions to remedy the problem ● Invasive species (phragmites, loosestrife) found below brook inlet south of Route 133 Bridge. ● Developed areas along shore range from clearcut lawn areas to well-planned plantings and shore walls. Information to shore landowners on their role in river conservation and prevention of erosion/pollution would help maintain the shore.

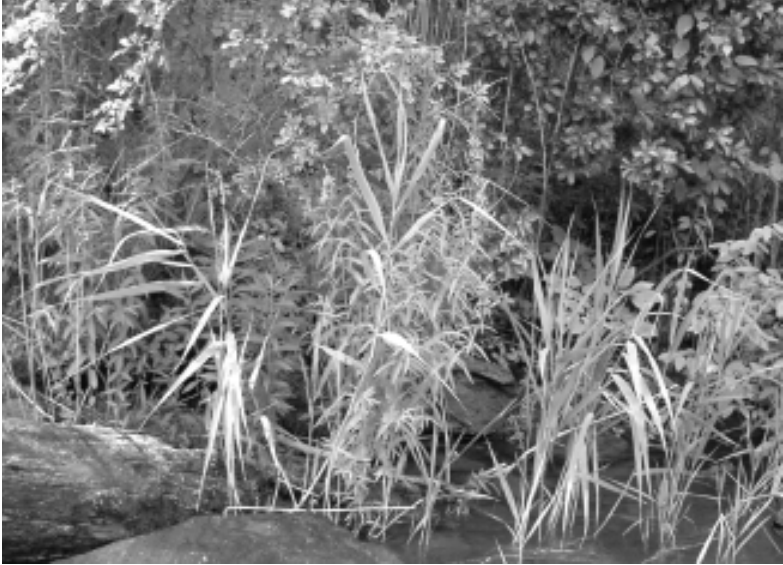
<p style="text-align: center;">Invasive species</p>

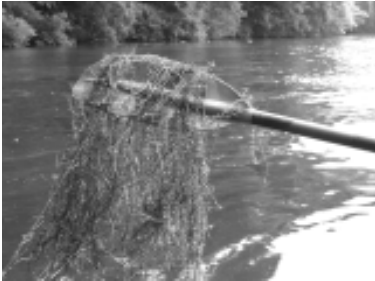
<p data-bbox="155 1062 527 1094">Aquatic vegetation on paddle</p>	<ul style="list-style-type: none"> ● Erosion on some steep slopes, from runoff as well as wake from boats. ● Lots of aquatic vegetation through entire survey area, some invasive species. ● Trash problem on some areas of the bank.

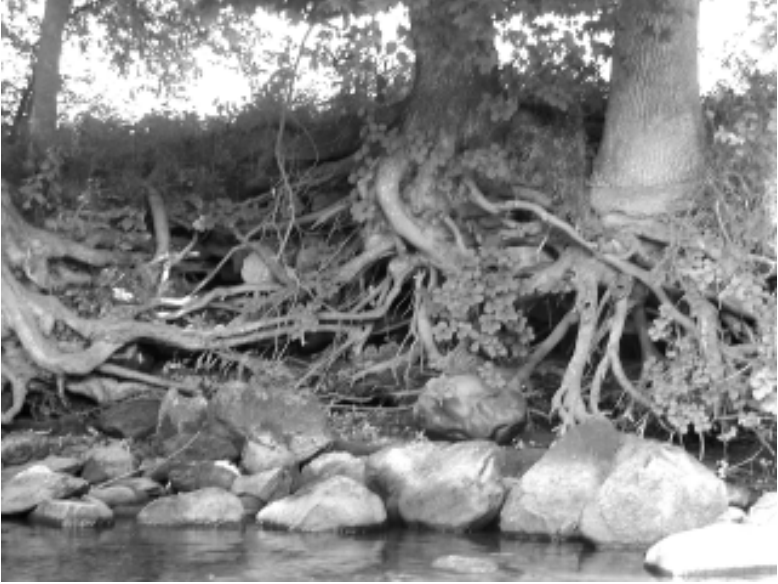
<p data-bbox="954 1881 1203 1913">Exposed tree roots</p>

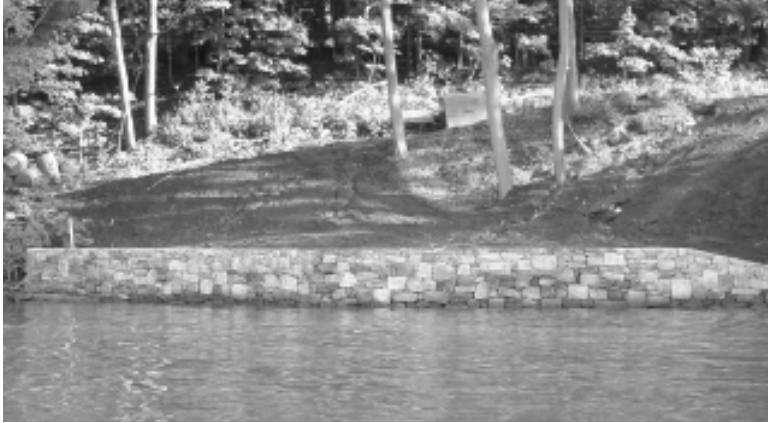
<p>Lawn cleared to retaining wall at the water's edge.</p>

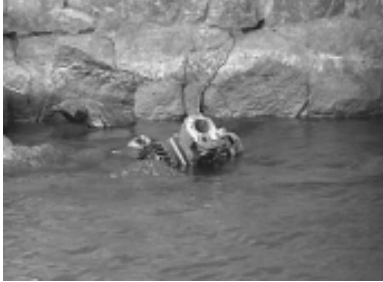
<ul style="list-style-type: none"> ● Look into actions to control silt near boat ramp. At least, place warning signs to boaters as the problem will only worsen. ● Control aquatic vegetation. ● Look into action against bridge runoff, possibly application of recent laws. <p>Motor dumped in lake</p>

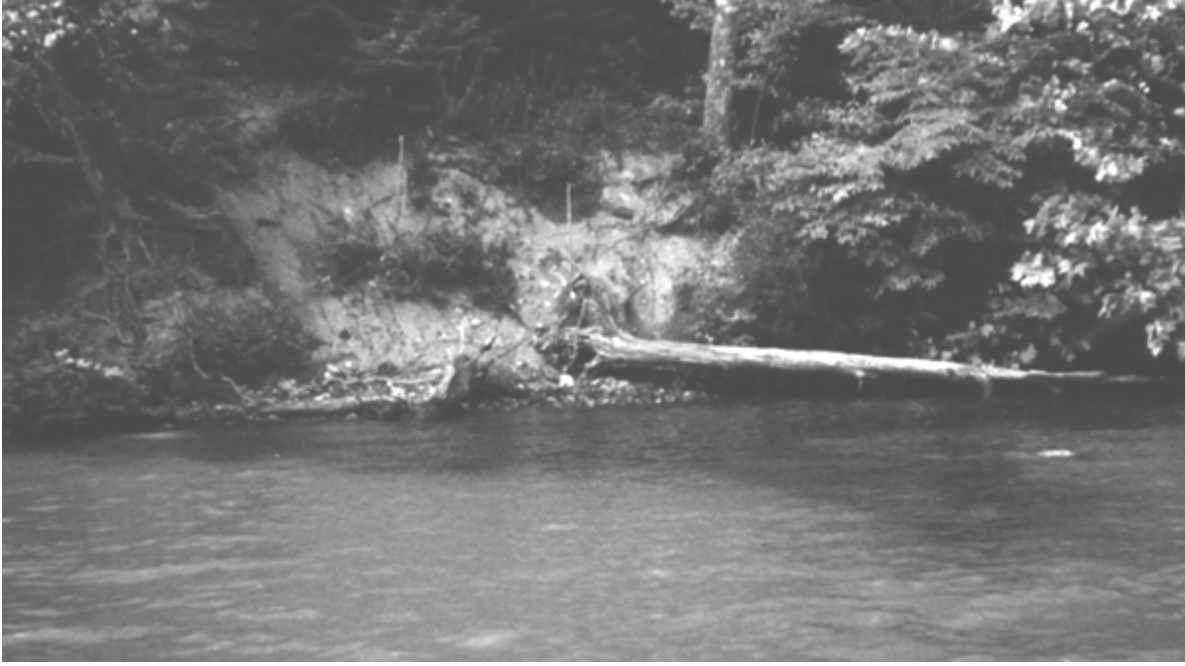
<p data-bbox="289 1213 457 1243">Eroded Bank</p>
