**SHORELINE
SURVEY
REPORT
&
ACTION
PLAN**

**Lake Lillinonah and Lake Zoar Stream Team
Summer 2002**

Housatonic Valley Association

LAKE LILLINONAH AND LAKE ZOAR STREAM TEAM REPORT

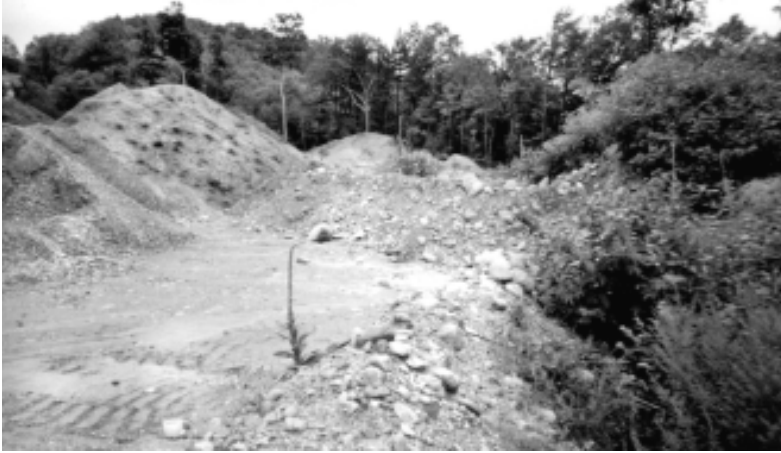
Natural Resource and Assets	Problems	Priority Actions
<ul style="list-style-type: none"> ● Lack of access in beginning area insures lack of development. ● Area by gravel pits have very good potential for canoe trail/take-out and campground. ● Steepness of slope and depth of water restricts area available for, and discourages growth of, invasive wetland species. <p style="text-align: right;">Sand and gravel mine</p>	<ul style="list-style-type: none"> ● Possible erosion problem from gravel mining operation. ● Garbage, broken bottles, and fire pits in beach areas by gravel mine.

<ul style="list-style-type: none"> ● Repair or replace erosion control devices at gravel mine operation. ● Clean up beach areas below gravel mine. ● Pursue easement of these beach areas.
